## Broken Air Conditioner Clutch Repair

by Flopster843

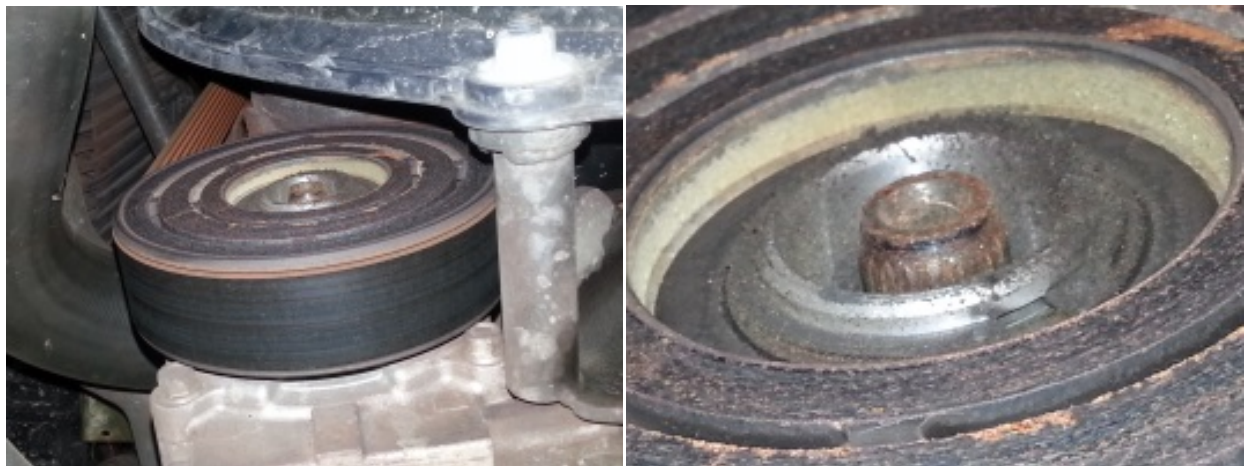
The main A/C clutch is held on the front of the compressor with a snap ring. The outside disk of the clutch (the part that actually engages the system) is held on with a single small bolt through the center. Like quite a bit of the hardware on a Dodge truck, it is nowhere near strong enough for the stress loads that are commonly placed on it. This results in that single bolt shearing off and usually ends with a complete compressor replacement. My bolt broke when I started my truck one early spring morning and left part of the clutch assembly lying in my driveway. It was still cold outside and I wasn't even using the air conditioner when it happened. A quick peek under the truck revealed that the bolt had sheared off inside the compressor shaft and it would need to be drilled.

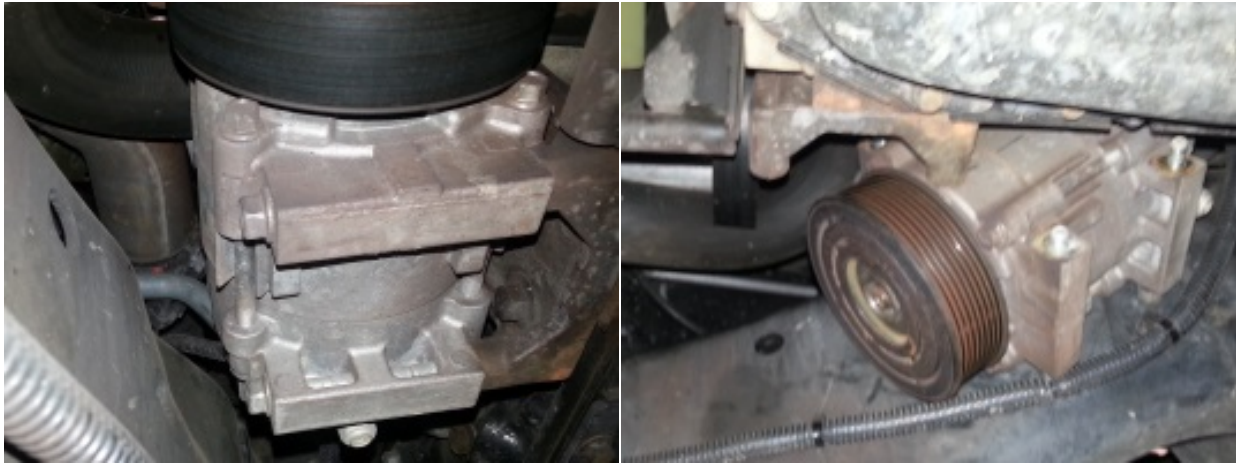
In order to access the compressor to drill the bolt, the compressor must be partially removed from the engine. It is possible to pull the compressor down enough to drill it without disconnecting the refrigerant lines, so you do not have to evacuate and recharge the system. I started by pulling the accessory drive belt (fan belt) off of the compressor pulley. There is a 1/2 inch drive key hole in the belt tensioner that allows you to remove the tension from the belt. It's nearly impossible to access, but it's there. I released the tension just enough to get the belt off of the compressor, all the other pulleys were not touched.

Once the belt has been removed, the compressor can then be removed. There are four bolts that go through the side of the compressor to hold it to the engine bracket. All 4 bolts have to be removed and then the compressor can be rotated downwards in order to gain access to the broken bolt.

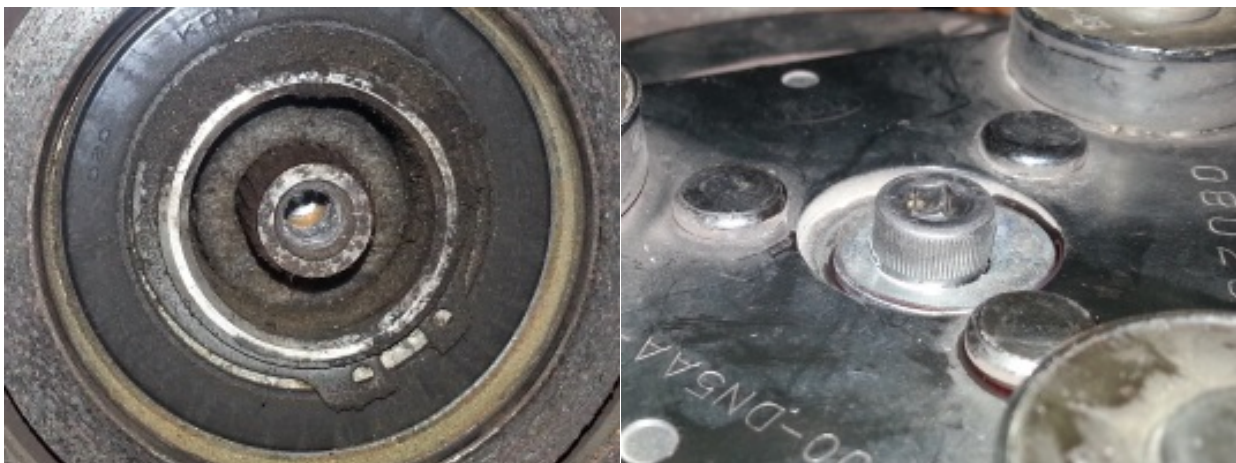
On a sensitive component like the A/C compressor, you've only got one shot to drill the bolt out. Any mistakes result in having to replace the entire compressor. To drill this bolt out, I utilized my Norseman left-handed drill bits. Read the transmission bolt fix article if you want some more information about this set. I highly recommend purchasing a quality set of left-hand drill bits if you attempt this yourself. I doubt an easy-out set would pull this bolt.

Through a slow and painstakingly long process, I was successful in removing the broken bolt from the compressor with minimal damage to the threads. All I had to do was to acquire a M6-1.0x25mm bolt to put back in it. The original bolt is supposed to be a grade 10.9, but it felt way too soft when I was drilling it to actually be a 10.9. I went to the local Fastenal store and was able to source a grade 12.9 bolt to replace it with. I reinstalled the clutch plate on the compressor using the new bolts covered in loctite thread locker. You will need to figure out a way to hold the clutch while you tighten the bolt. A long screw driver can be wedged across the front of the clutch to hold it still, but it requires an extra set of hands to hold in place. After the clutch is reinstalled, the compressor was bolted back to the engine bracket. Finally, the belt can be reinstalled to finish this project.

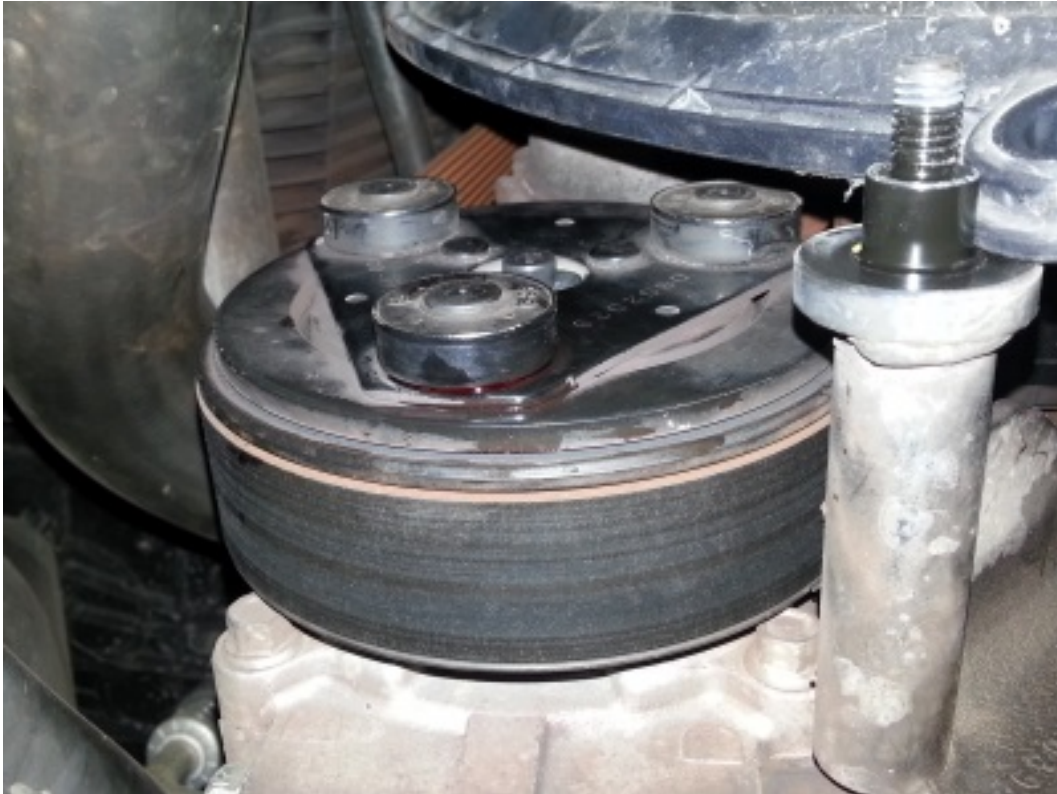
Like I said at the beginning, if you replace this bolt before it breaks you will save yourself a lot of work. The bolt can be removed and replaced without taking off the belt or dropping the compressor. You also don't have to worry about trying to drill a tiny screw out of a tiny hole. I highly recommend you pick up a replacement bolt and swap it out before your bolt breaks, which could possibly require a complete compressor replacement.
